**BANK BARNs COMPARED
WITH ABOVEGROUND BARNs**

**FOR HOUSING
DAIRY CATTLE**

by Max J. LaRock and
Robert G. Yeck

Production Research Report No. 2

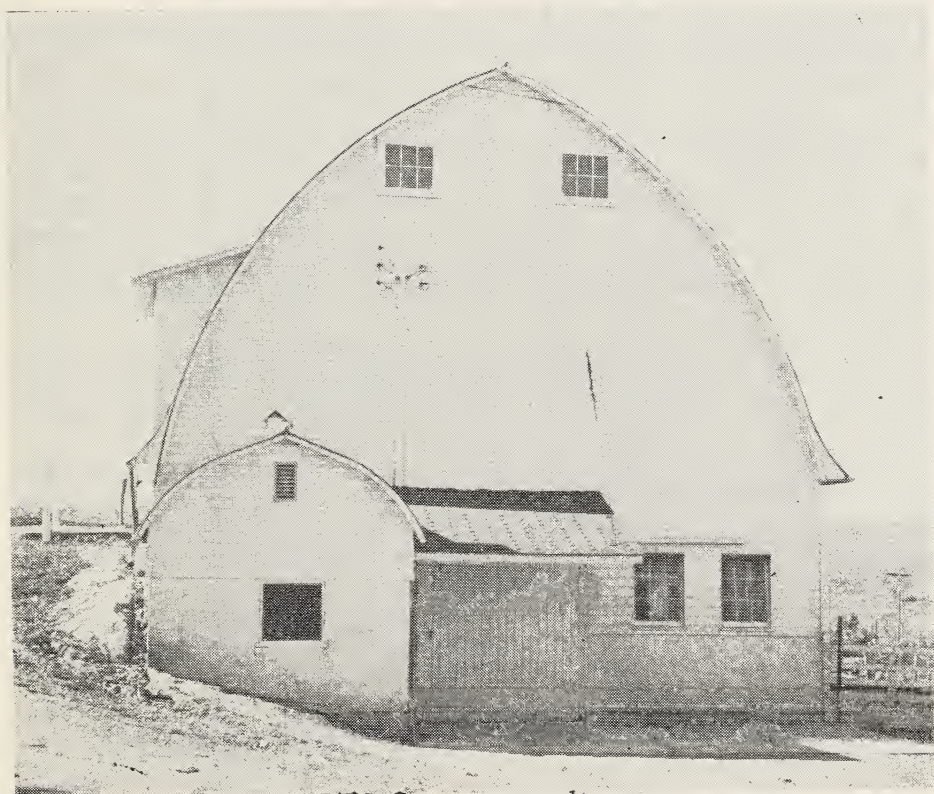
FIGURE 1.—A bank barn, showing the ground-level approach to the second floor made possible by the earth bank.

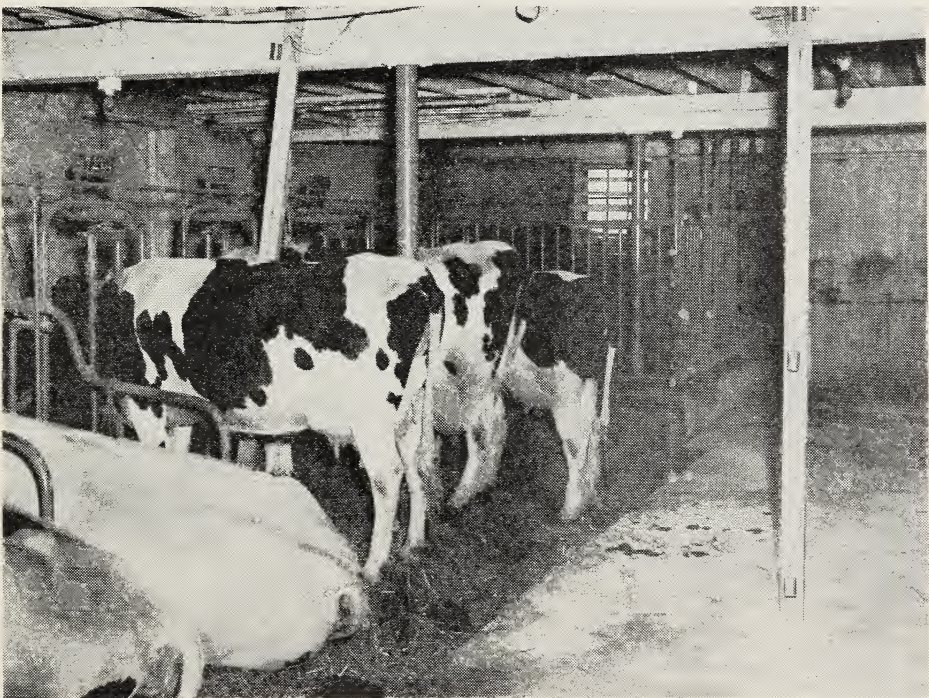
FIGURE 7.—Interior of bank barn 15, showing two of the supporting stands for the air-temperature thermocouples of the 16-point recording potentiometer. One extends from the bank to the floor in the center-service (litter) alley, and the other extends from the bank to the floor immediately to the left of the steel posts between the cows.

A continuous record of the temperature was obtained at each of several points within aboveground barn 6 and bank barn 15. The temperature was measured with a multipoint recording potentiometer that recorded one set of measurements (80 points, some of which represented surface temperature) every 20 minutes. The thermocouple detecting element was shielded from radiation and supported by a thermocouple stand at each of the 3 levels of measurement. (See fig. 7.)

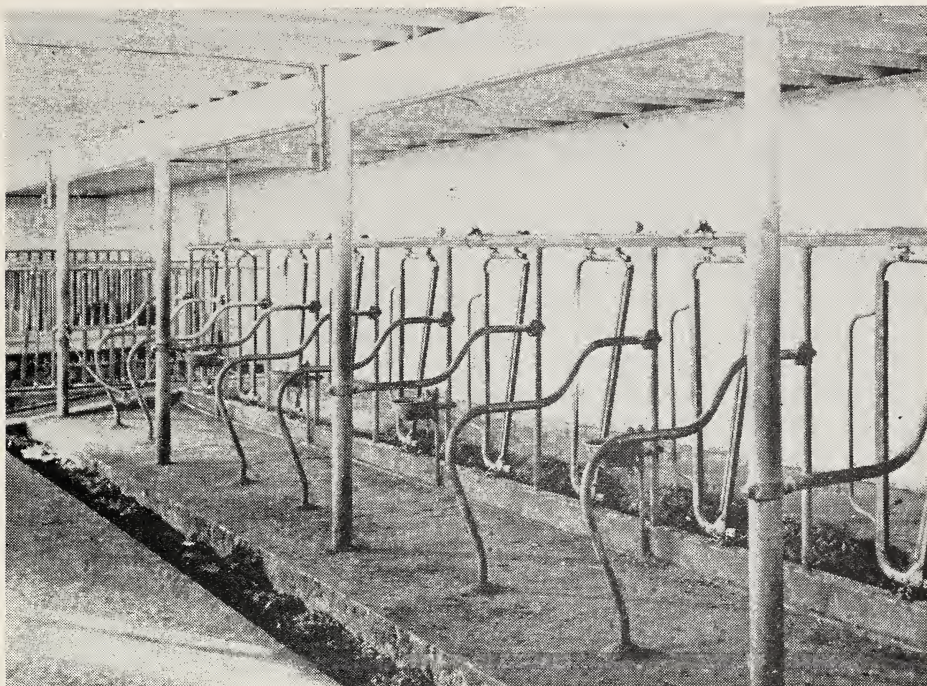
FIGURE 13.—Interior view of bank wall in a bank barn. The lack of windows is offset by the whitewashed wall that reflects light well. A clear expanse of wall such as this is easy to keep clean.

possible means of overcoming these differences. Figure 13 shows the inside surface of a typical windowless bank wall in a bank barn.
